# **Rocky Mountain Section AAPG Meeting Bakken Play Essentials September 24, 2005**

**Multilateral Completion and  
Williston Whipstock Misalignment  
study**

**Gary Gill Schlumberger  
Ron MacDonald APA**

# Williston Whipstock Misalignment study

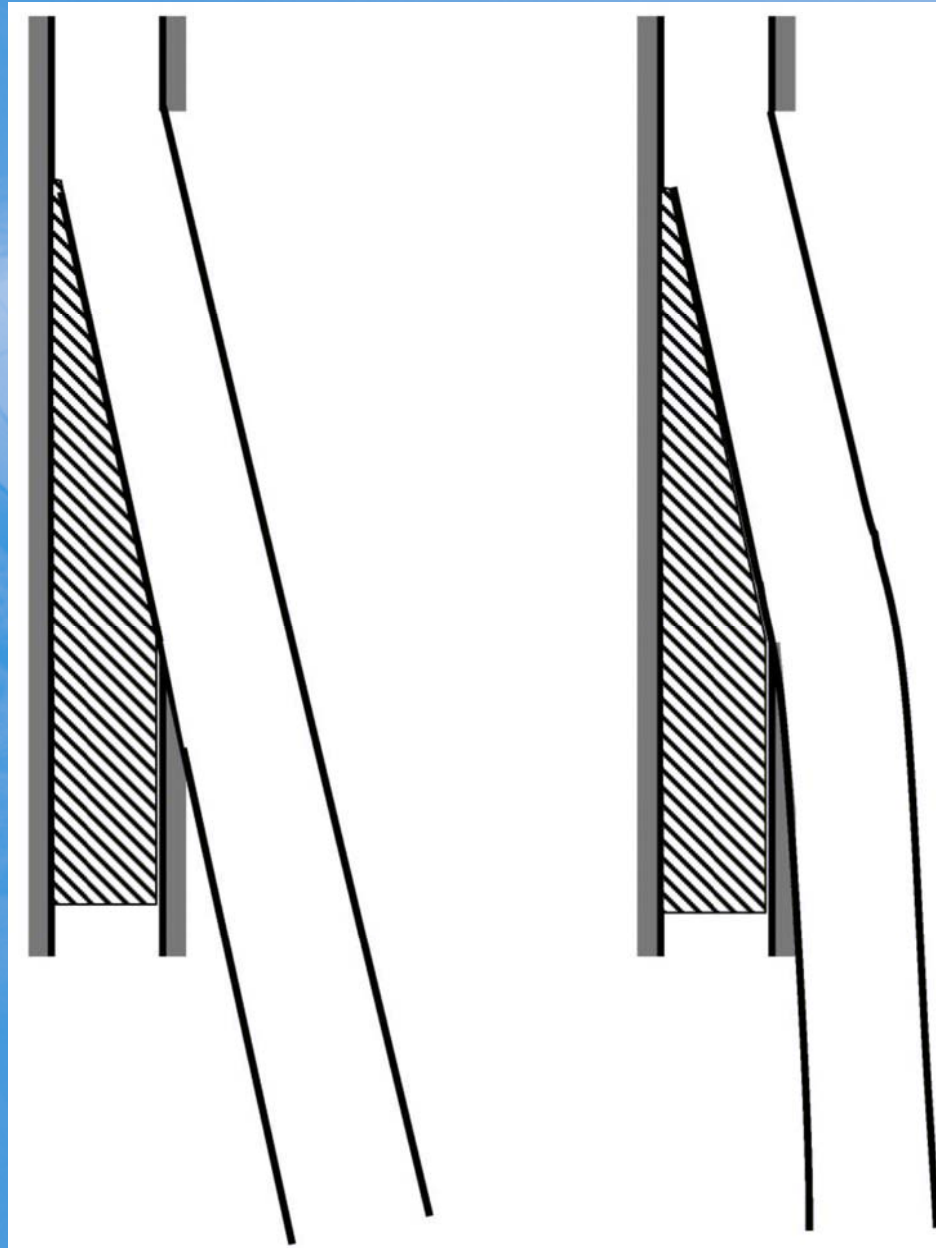
# Inclination change

<b>Cause</b>	<b>Possibility</b>
Surface Misalignment	Low
Downhole Misalignment	
- Gyro	Low
- CSLT Landing	Low
- Downhole String Make-up	Low
Milled Window Roll Off	High
Milled Rathole Inclination Change	High
Gyro Survey Error	Low
